Jackson County Courthouse

85 Washington St.

Project Statement

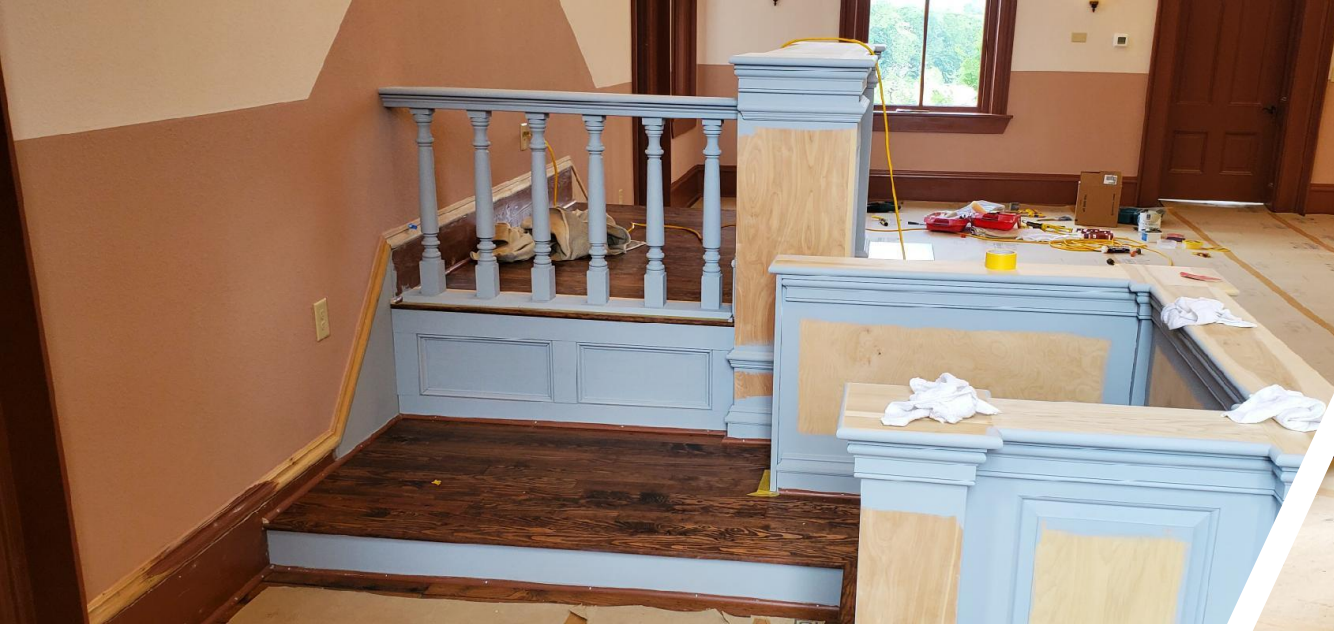
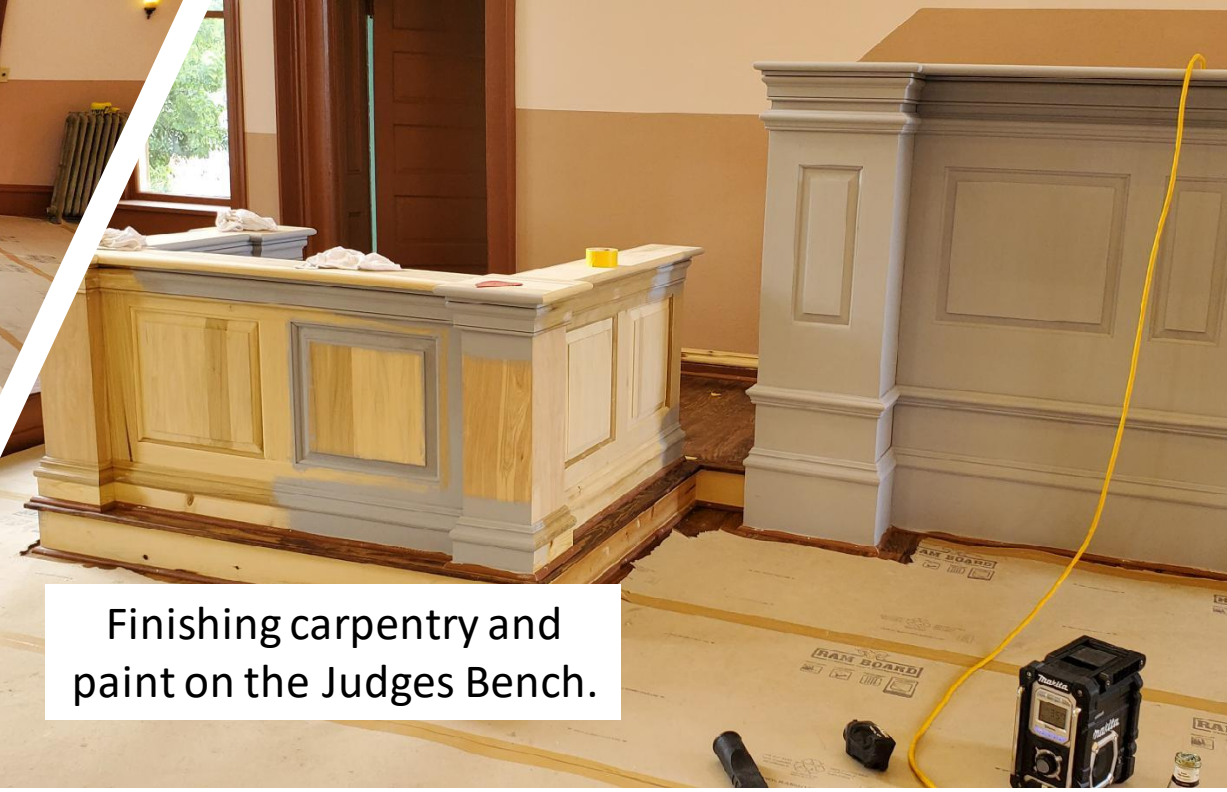
Finishing carpentry and paint on the Judges Bench.

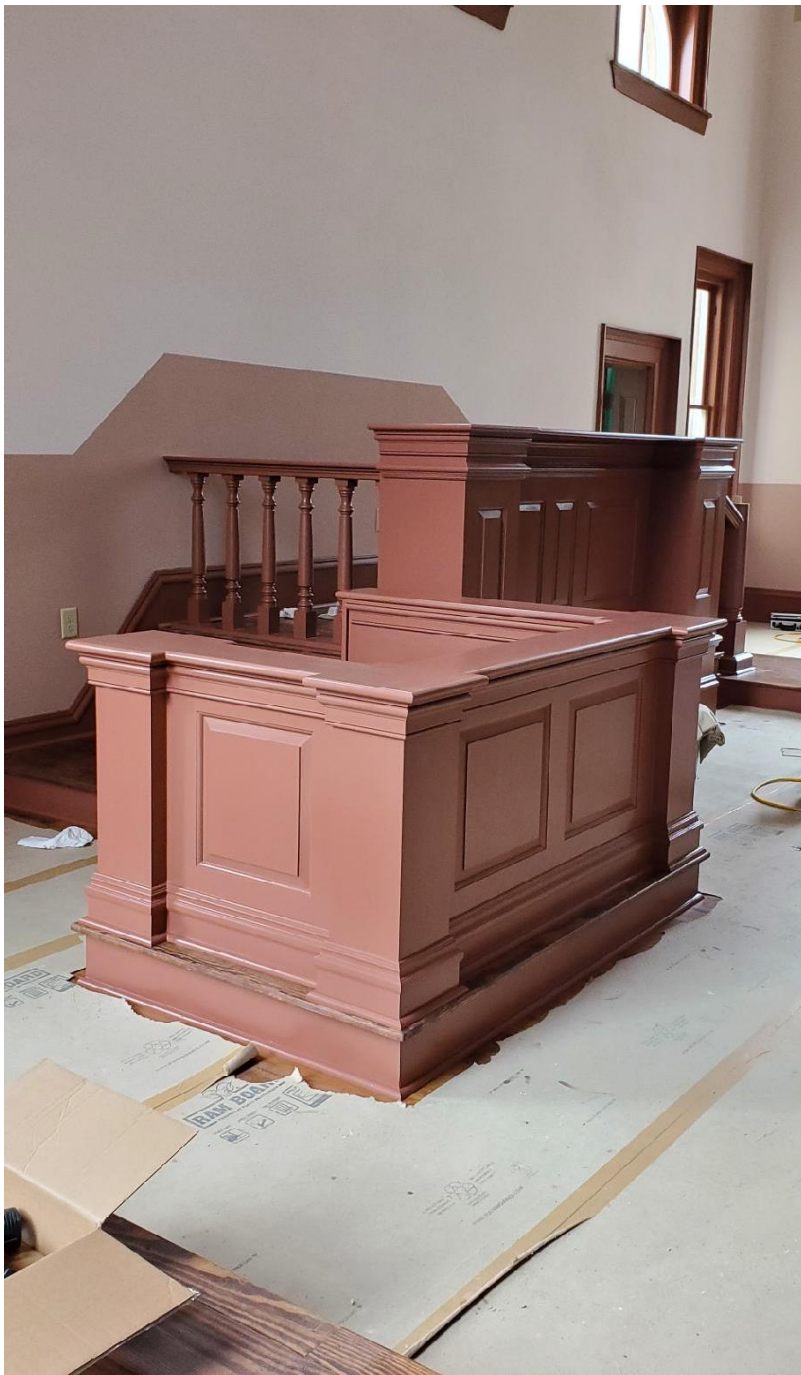
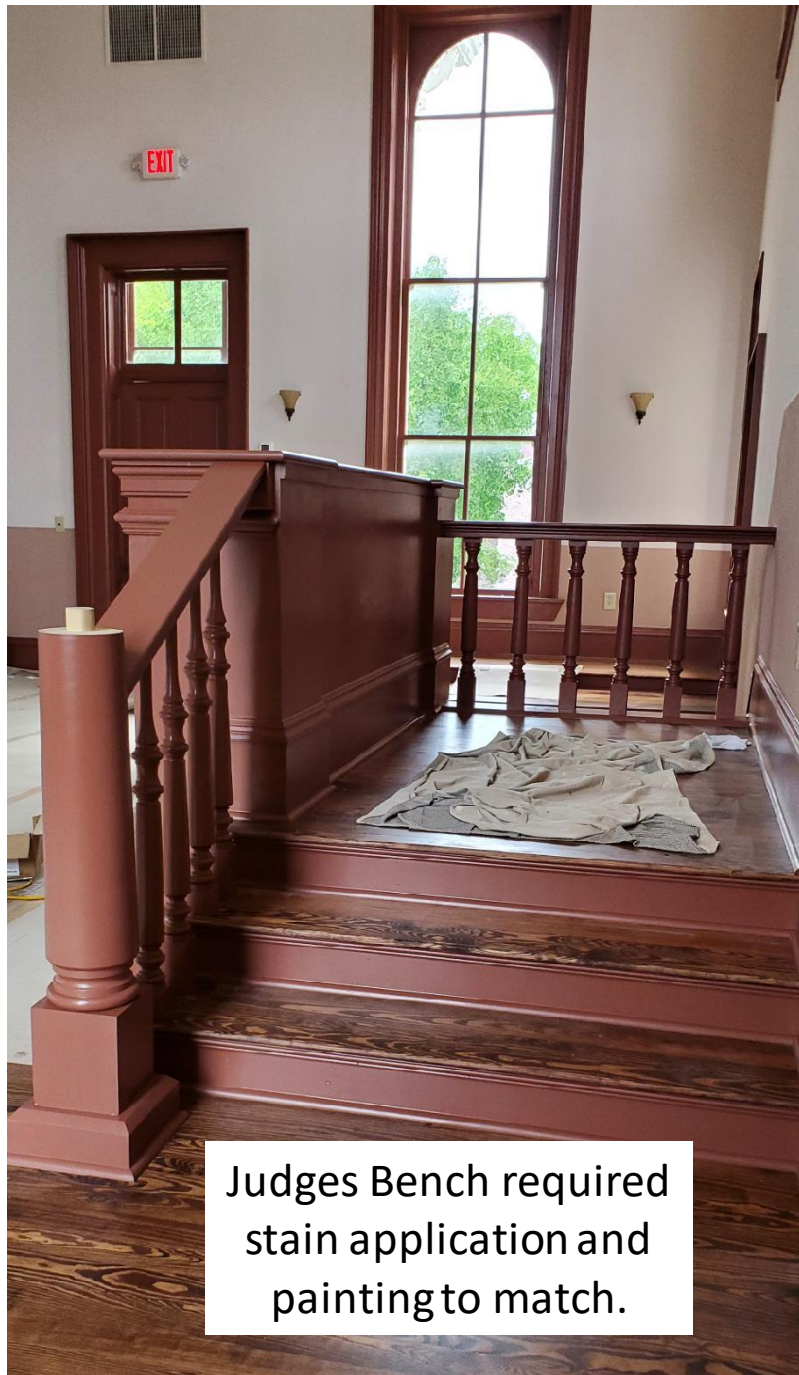
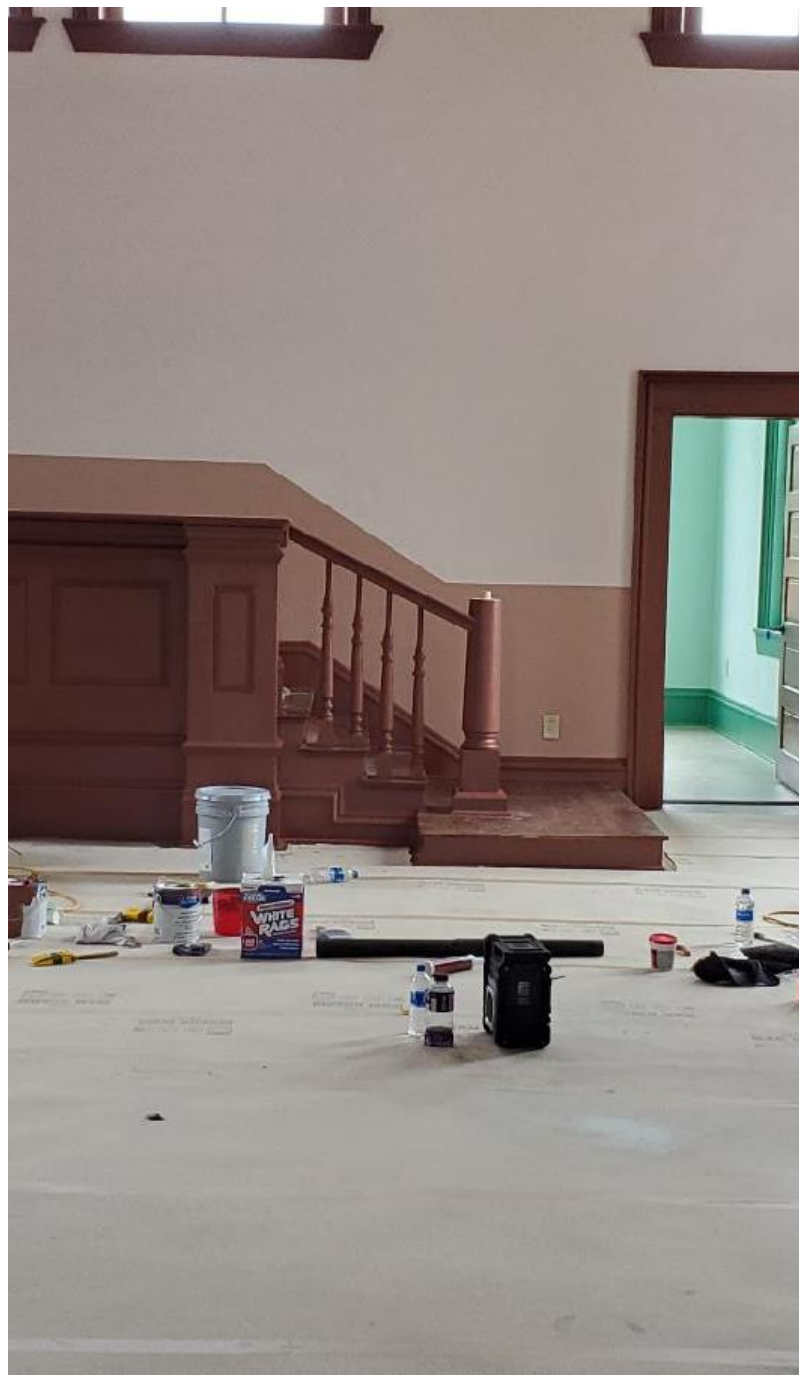
Judges Bench required stain application and painting to match.

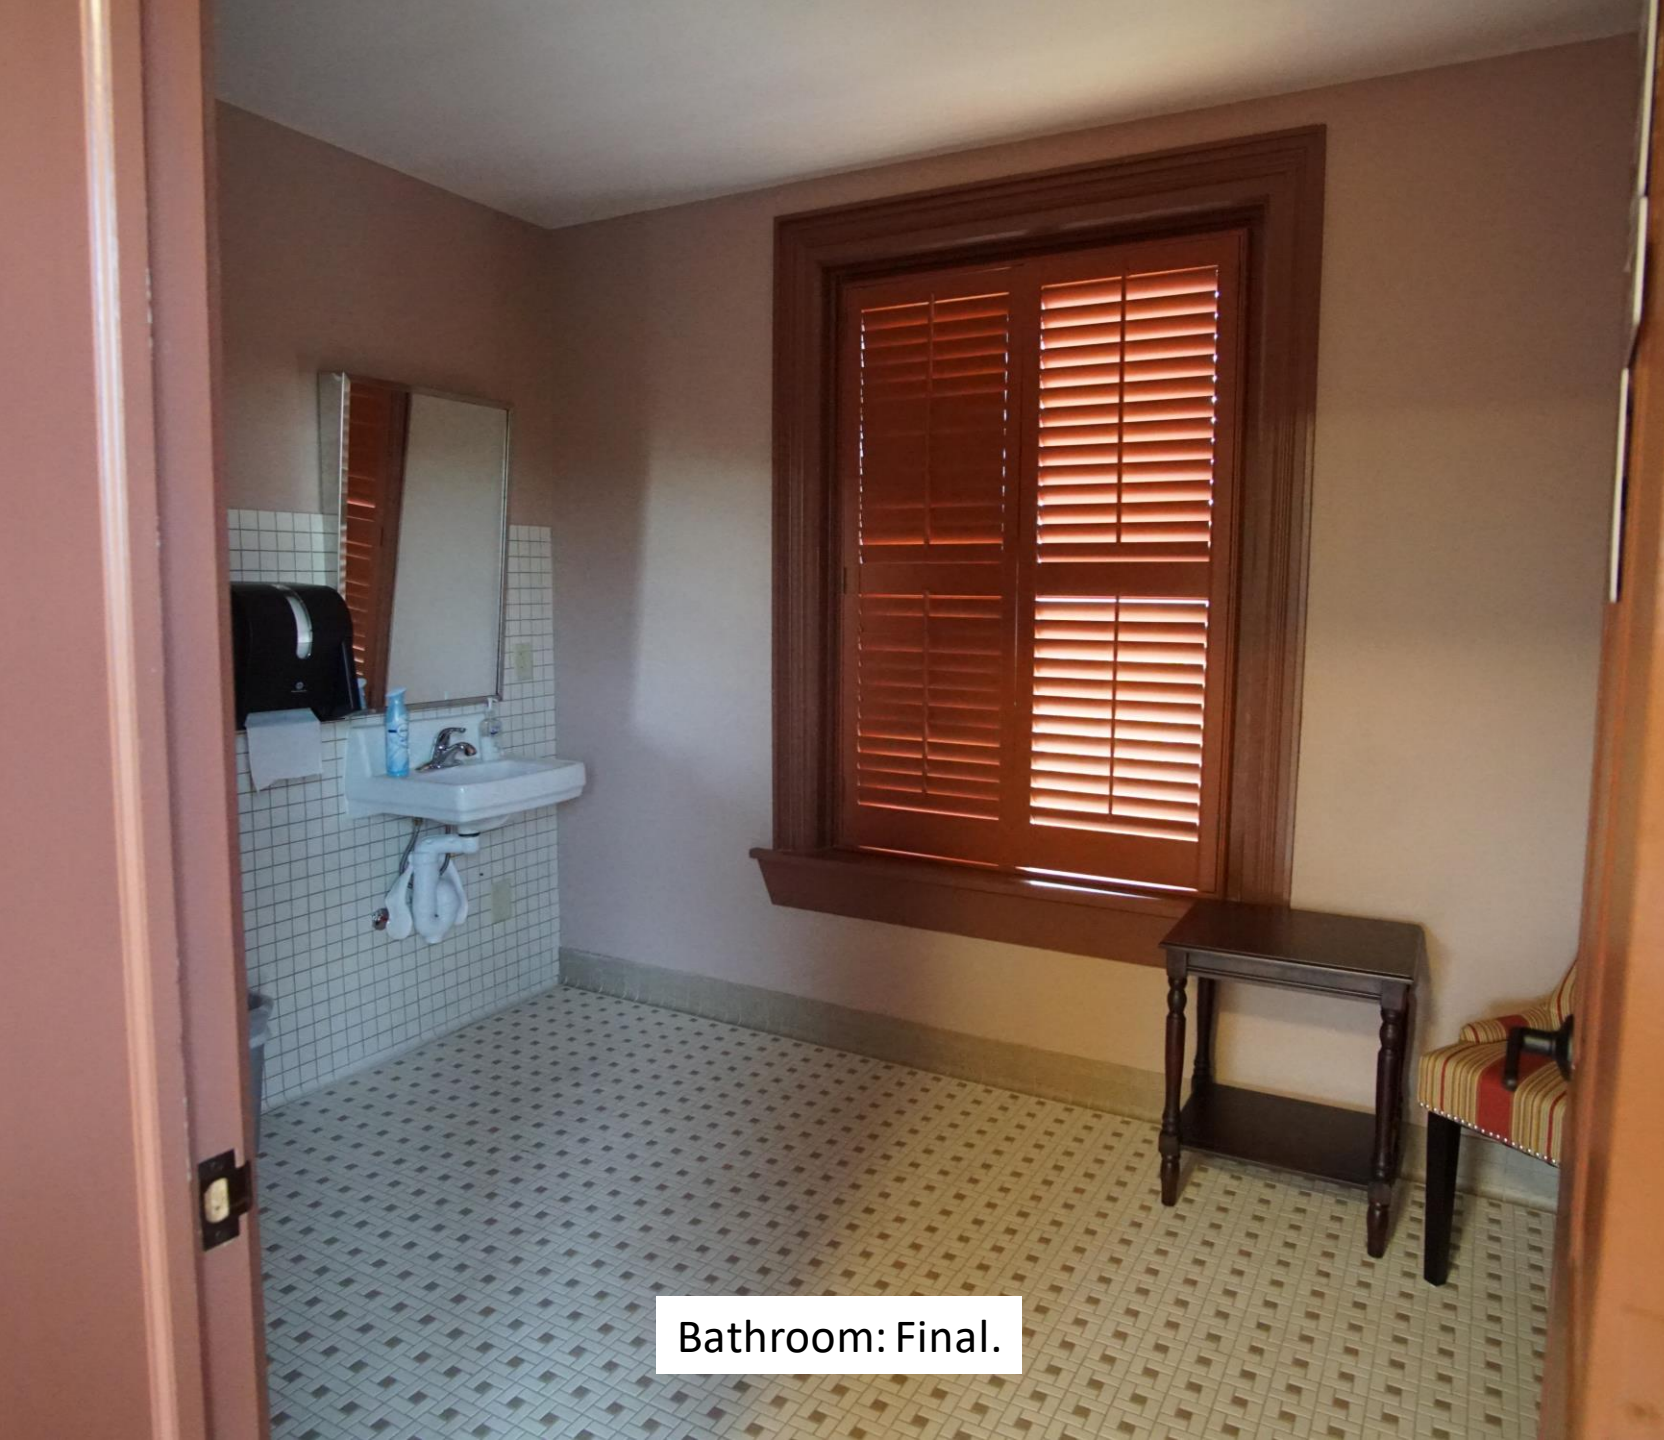
Bathroom: Final.

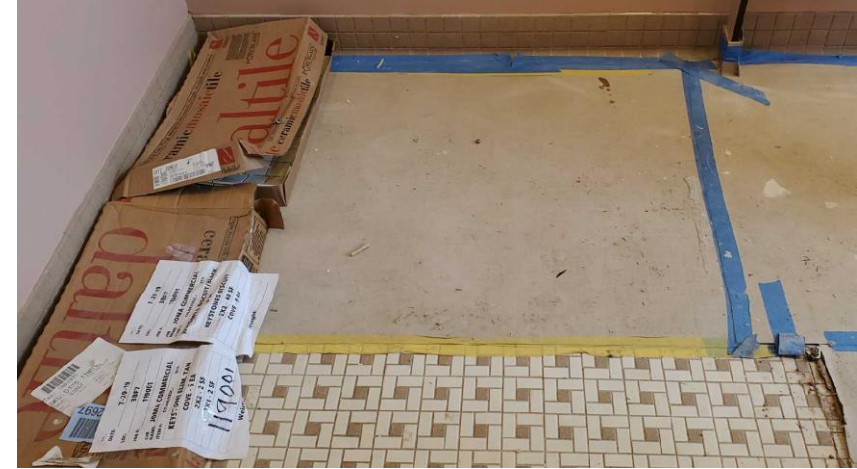
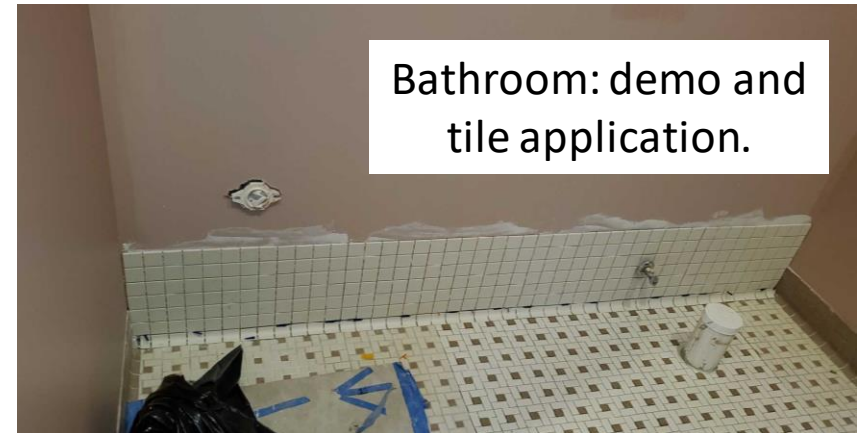
Bathroom: demo and tile application.

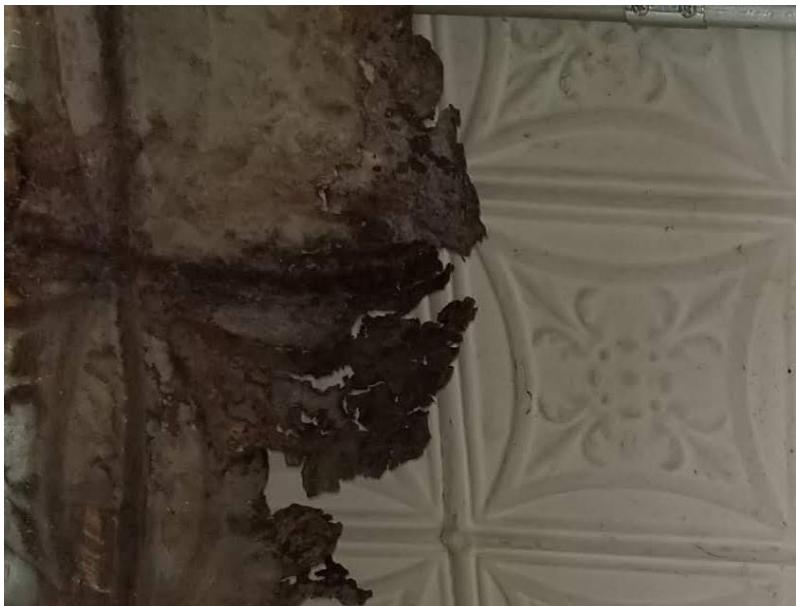
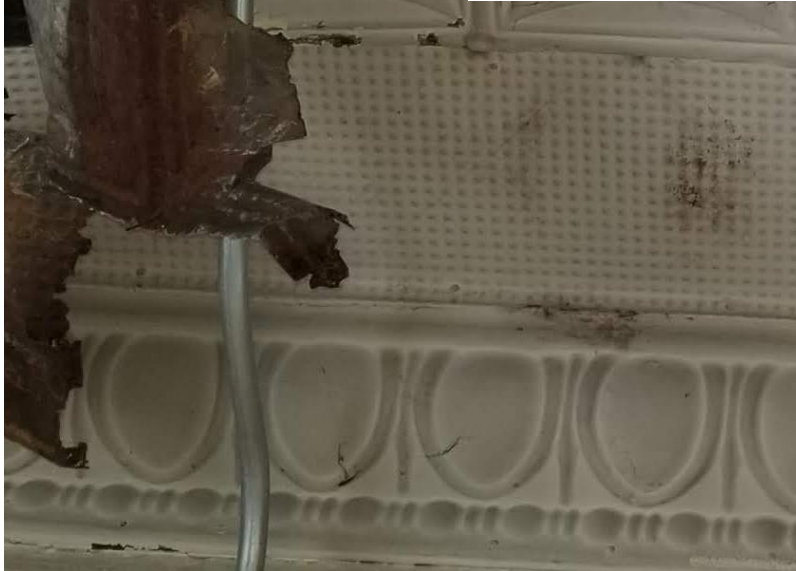
Extensive Blocking was installed to accommodate the custom metal ceiling tiles.

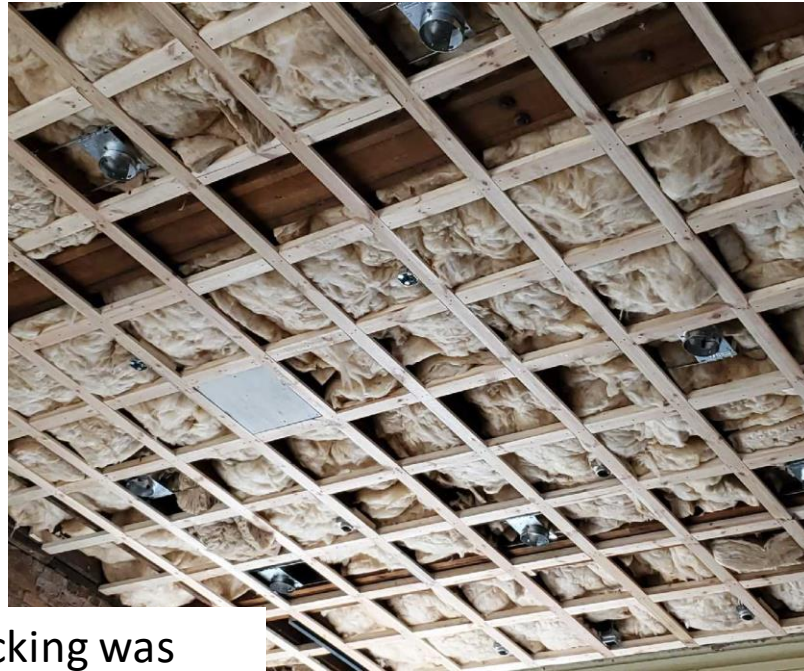
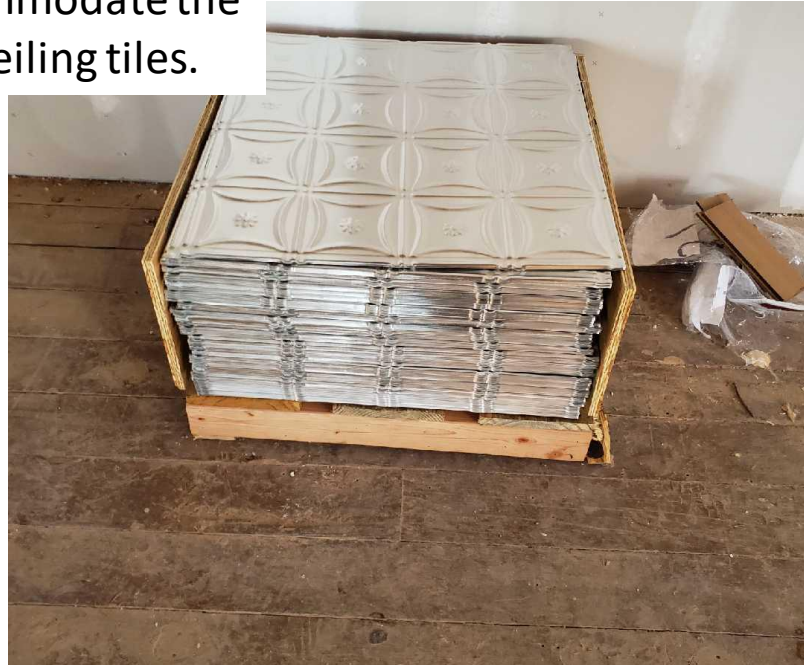
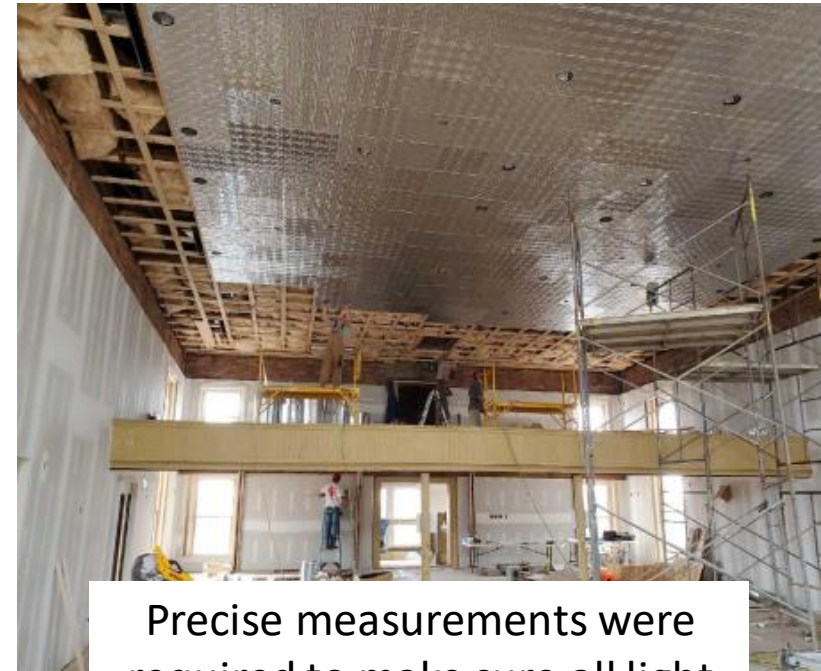
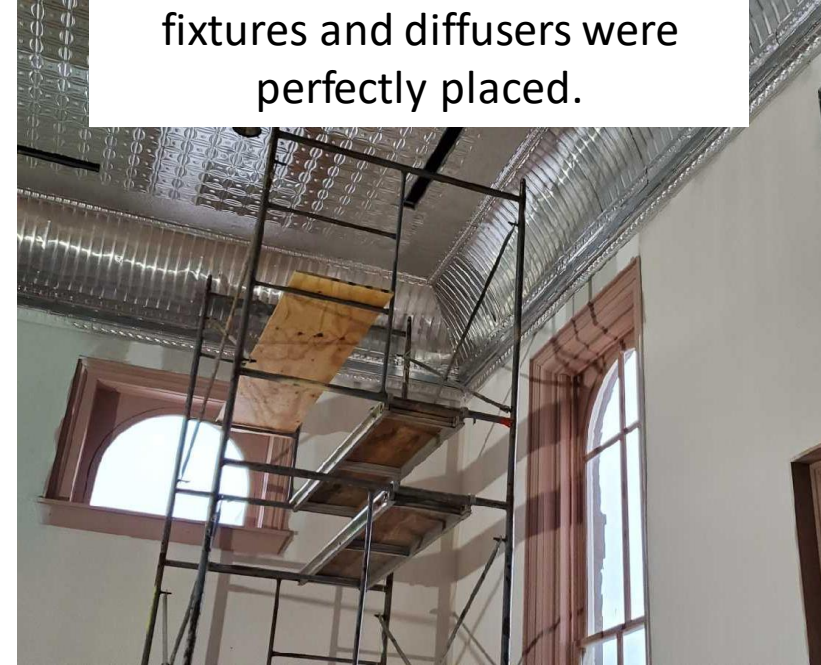
Precise measurements were required to make sure all light fixtures and diffusers were perfectly placed.

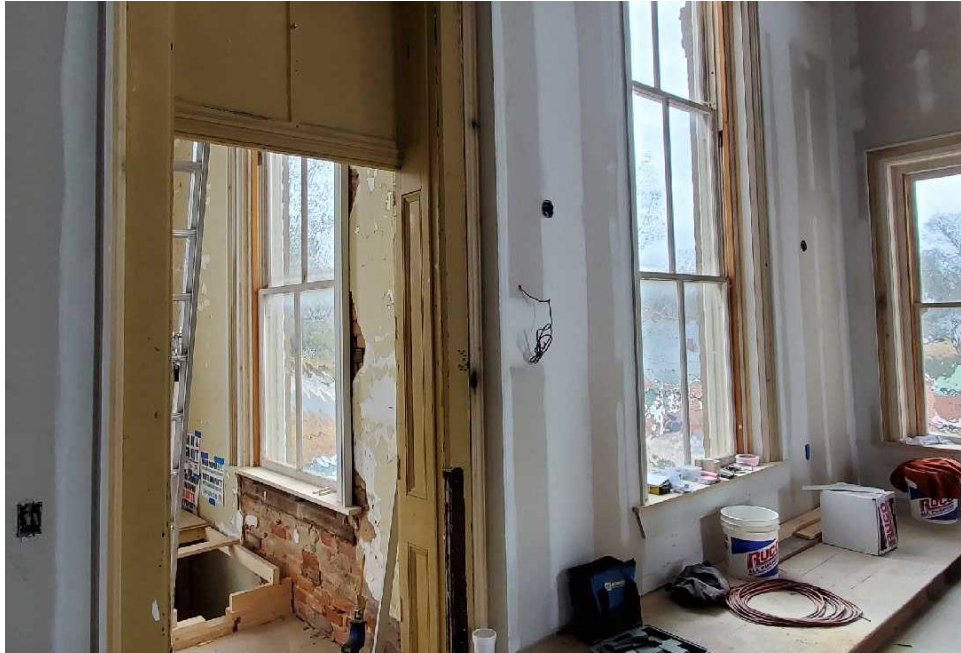
Finishing paint touches/finished carpentry wrapped around door casing to match existing.

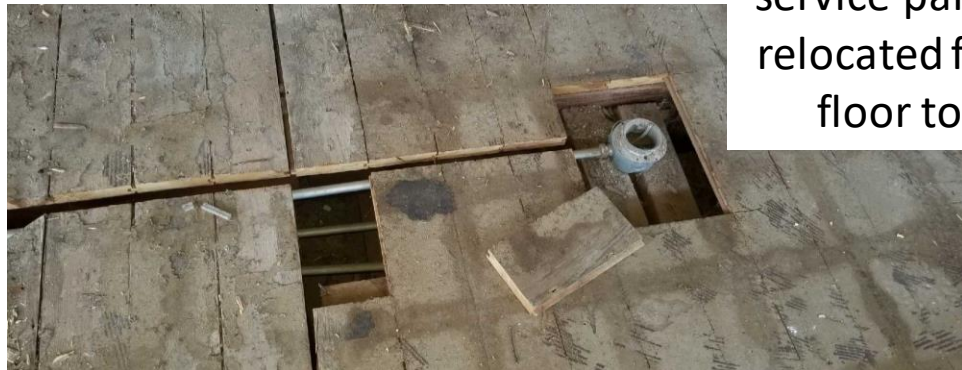
Electrical conduit discovery; the first floor service panel had to be relocated from the first floor to the attic.

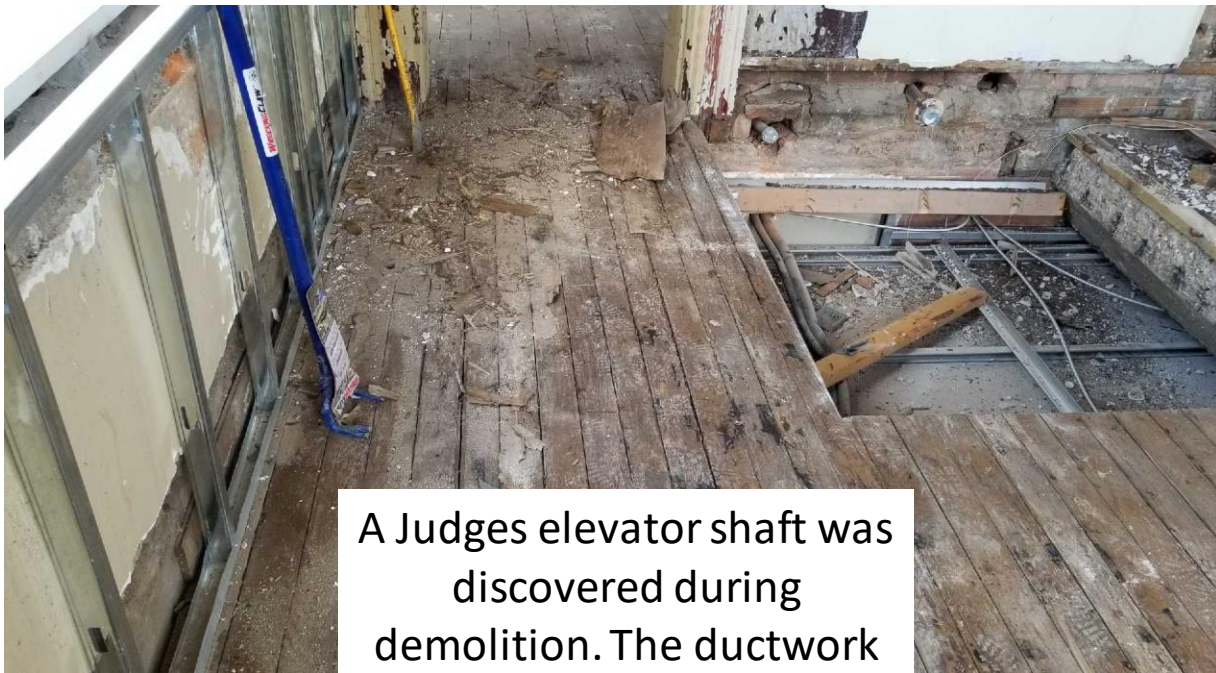
A Judges elevator shaft was discovered during demolition. The ductwork had to be strategically chased down the tight fitting shaft.

The mechanical systems had to be designed to accommodate a building constructed in 1879 with no modern building envelope insulating systems and for a very large room approximately 75,000 cubic feet with 14' windows, most nearly 15' high. Additional structural designs accommodated the units above the ceiling in the courtroom. The only aesthetically satisfactory location to install the exterior condensing units was nearly the maximum distance allowed for the line sets, resulting in some very creative routing. Luckily, the chimney that was discovered had enough room for the multiple line sets as well.

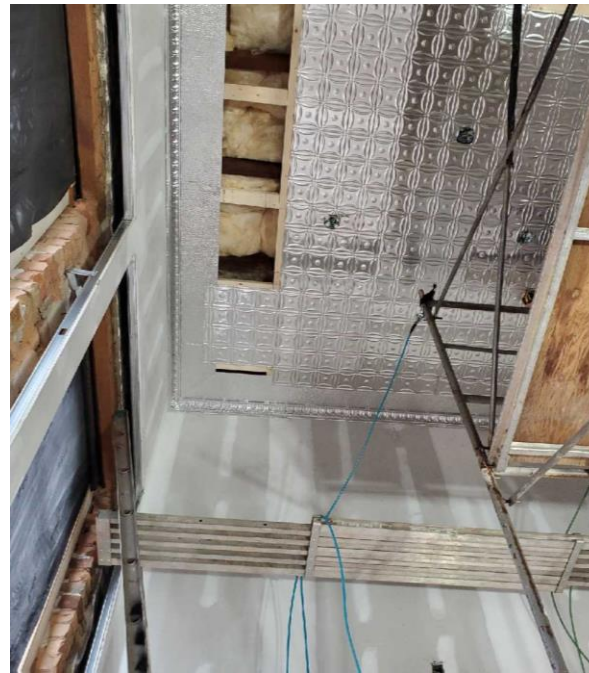
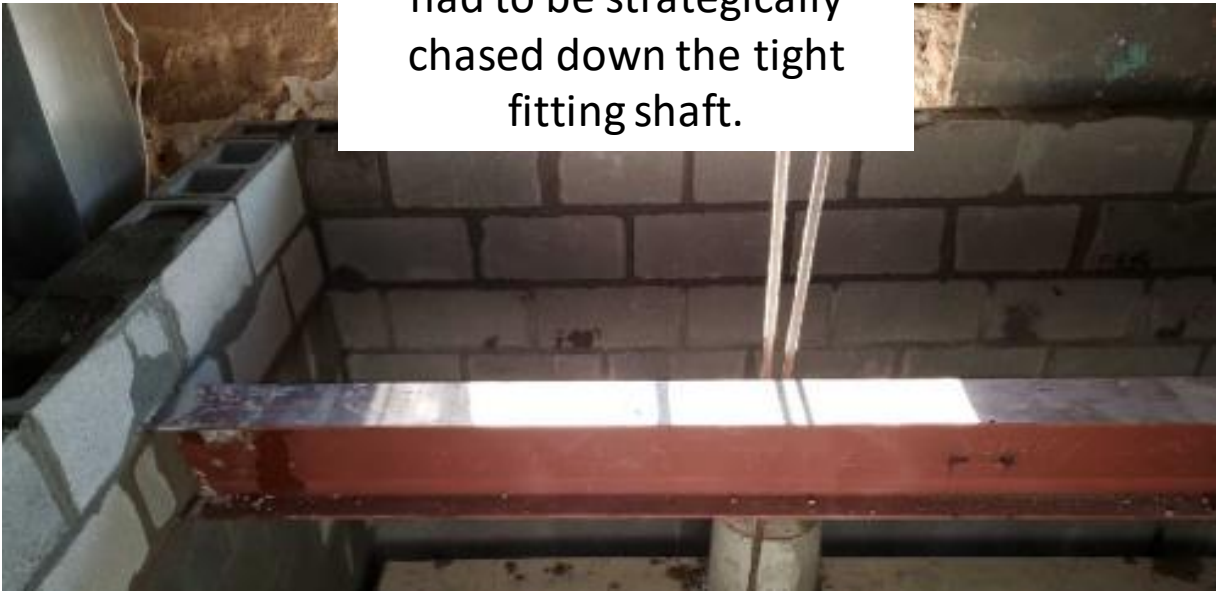
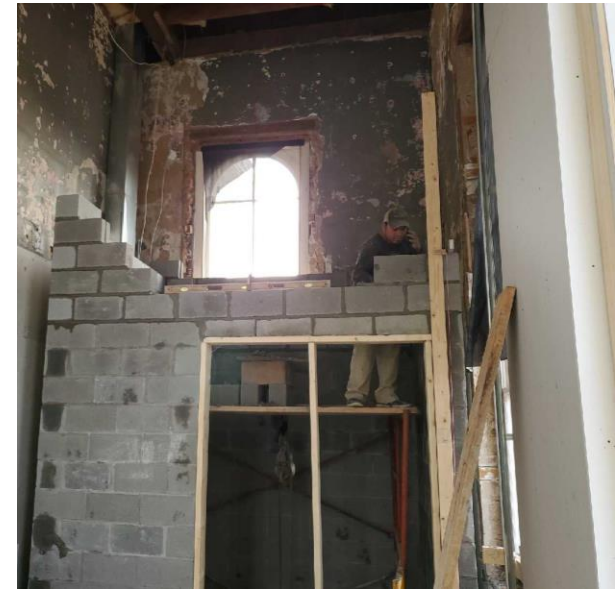
Elevator: before and after.

The elevator was a challenge. The elevator pit was located on the first floor beneath an existing janitor's closet, which included a mop sink, electrical, and the main panel box, all of which had to be relocated. All existing electrical and plumbing were relocated, the floor was carefully demoed, and an old water well or storage room constructed of brick was discovered. The dirt beneath the floor had to be hand-dug, brick chipped away, and removed from the building via wheelbarrow, to accommodate the 4' deep elevator pit.
